# Manhole Inspection Summary

Manhole # S47KK\_019MH

Insp Date: **5/5/08 1:44 PM**

**Location** Address: **Lanvale St**

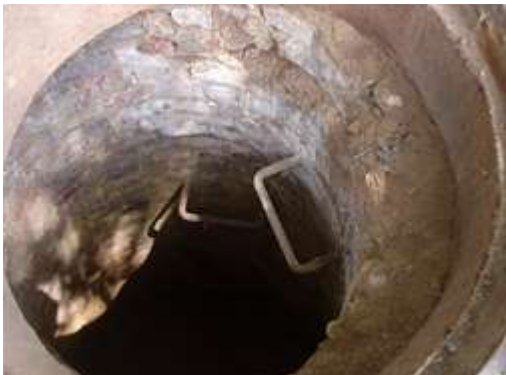
Defect 1

Condition: ☐ Sound ☐ Cracked ☐ Root Intrusion ☐ Loose Brick ☒ **Deteriorated**

Infiltration: ☐ None ☒ **Joint** ☐ Cracks ☒ **Mortar** ☐ Roots ☐ Wall

Deterioration

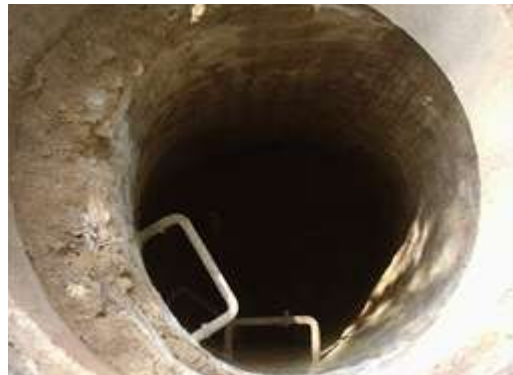
Defect 2

**Frame** Offset: **4** (in.) Condition: ☐ Sound ☐ Cracked ☒ **Leaks**

Frame Leaks

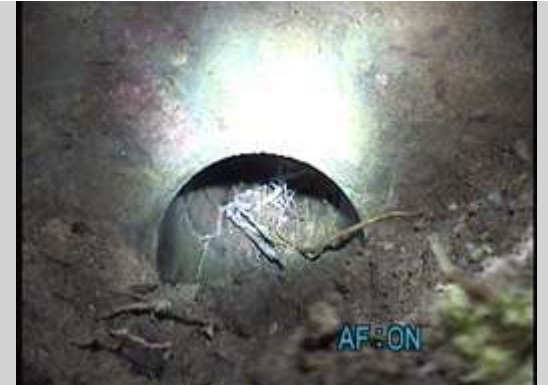
12 O'Clock Outflow

8 in. Circular Gravity Sewer  
Pipe Out @ 12 O'Clock

Deposits: ☐ None ☒ **Mud** ☐ Sludge ☒ **Debris** ☐ Grease

Silt Depth: **4** (in.) Deposits Extent: **Medium**
